CARNEGIE STATE VEHICULAR RECREATION AREA EXPANSION AREA

DELINEATION OF STATE AND FEDERAL JURISDICTIONAL WATERS

February 2018

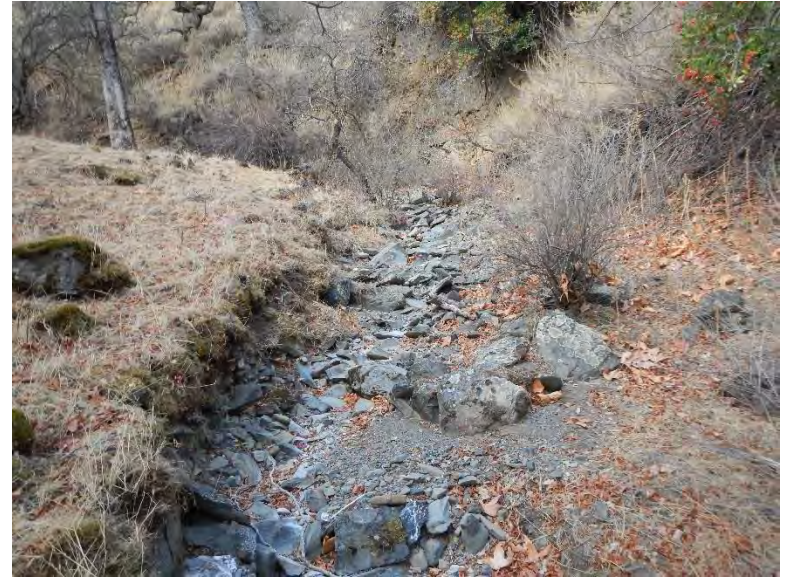
Photo 5: Drainage 2

Drainage 2 is an unnamed ephemeral drainage feature which is completely contained within the Carnegie SVRA Expansion Area. Following significant storm events, surface water is conveyed into Drainage 2 from the surrounding landscape, and into Corral Hollow Creek. Drainage 2 is a direct tributary to Corral Hollow Creek. Drainage 2 exhibits an earthen streambed characterized by substrate consisting of gravel, and cobble. No surface water was observed within Drainage 2; however, evidence of a Corps OHWM was observed via the following; scour, drift/debris, sediment deposition, and changes in terrestrial vegetation. Drainage 2 measures approximately 1,444 linear feet in length, and 2 feet in width for the Corps and 2 feet in width for the CDFW.

The channel invert of Drainage 2 is primarily unvegetated. Native vegetation present along the banks during the site visit included blue oak (UPL), California sagebrush (UPL), California buckeye (UPL), California sycamore (FAC), California foothill pine (UPL), and poison oak (FACU). No dominant hydrophytic vegetation was observed within Drainage 2; therefore, soil samples were not warranted.

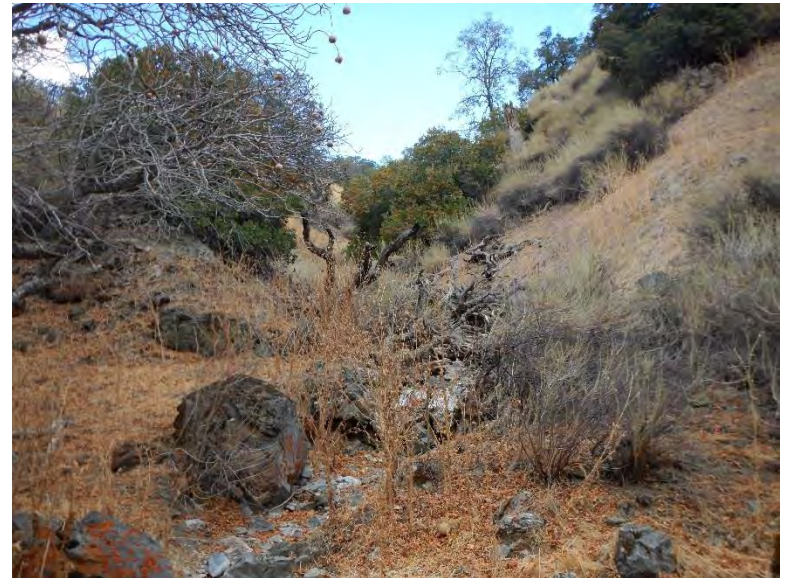
Photo 7: Drainage 4

Drainage 4 is a steep unnamed ephemeral drainage feature which is completely contained within the Carnegie SVRA Expansion Area. Following significant storm events, surface water is conveyed into Drainage 4 from the surrounding landscape, and into Corral Hollow Creek. Drainage 4 is a direct tributary to Corral Hollow Creek. Drainage 4 exhibits an earthen streambed characterized by substrate consisting of gravel, cobble, and boulders. No surface water was observed within Drainage 4; however, evidence of a Corps OHWM was observed via the following; scour and changes in terrestrial vegetation. Drainage 4 measures approximately 2,610 linear feet in length, and 2 feet in width for the Corps and 2 feet in width for the CDFW.

The channel invert of Drainage 4 is primarily unvegetated. Native vegetation present along the banks during the site visit included blue oak (UPL), California sagebrush (UPL), California buckeye (UPL), and poison oak (FACU). Non-native species included ripgut brome (UPL), Italian thistle (UPL), and wild oat (UPL). No dominant hydrophytic vegetation was observed within Drainage 4; therefore, soil samples were not warranted.
